Special Report:

How to Meet Federal Mandates Impacting Bridges with T-1 Steel

Federal Mandate Addresses Need to Inspect Bridges Built with T-1 Steel

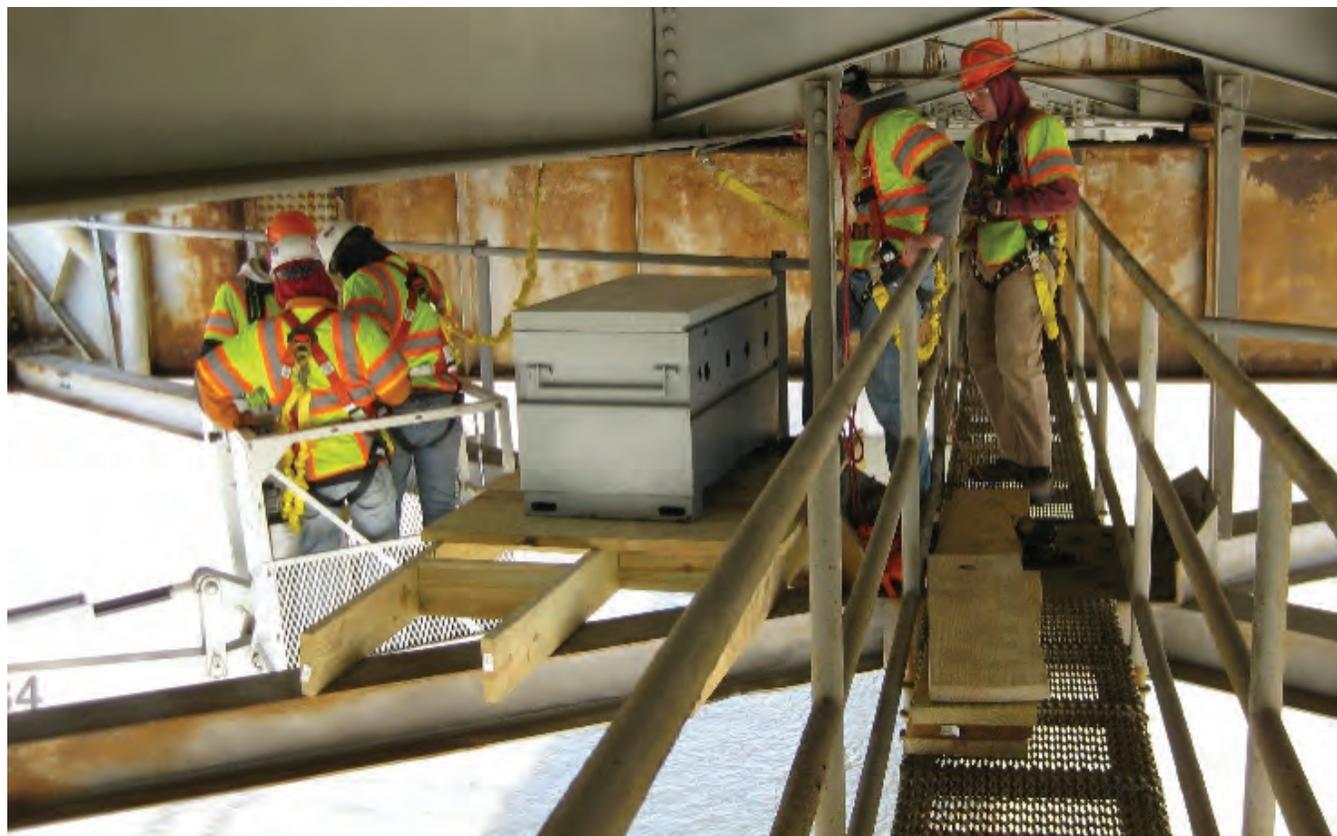
Nondestructive Evaluation personnel inspecting the Sherman-Minton Bridge. (Fickett Photo)

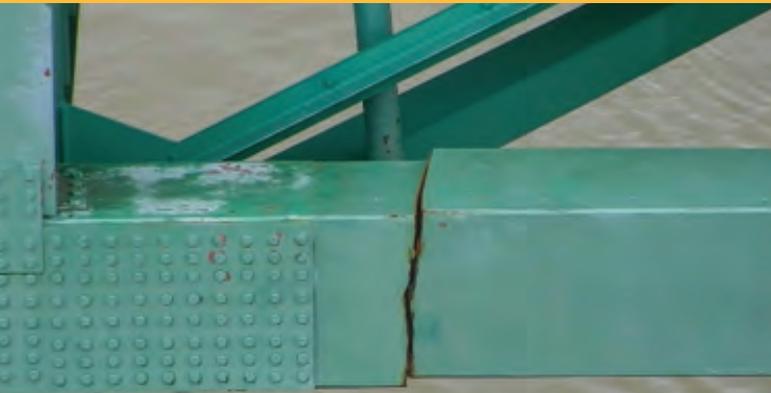
Hernando de Soto Bridge tie bridge fracture (Photo Courtesy Arkansas DOT)

On May 11, 2021, an inspector from Michael Baker International discovered a fracture in one of the main span tension tie girders. The fracture occurred at a butt-welded joint.

The structure, which carries four lanes of interstate traffic over the Mississippi River, was immediately closed because of safety concerns, halting vehicular and maritime traffic. After the investigation, it was determined that hydrogen cracking was the probable cause of the weld fracture.

This structure is a fracture critical tied arch-truss bridge that consists of two 900-foot main spans. The box-shaped tension tie girders of the main spans were fabricated with T-1 steel.

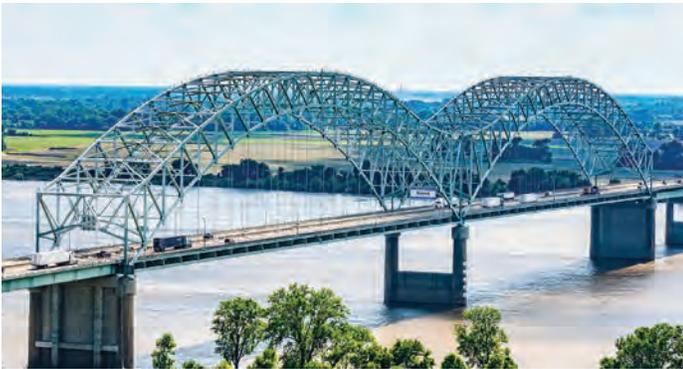
1-40 Hernando de Soto Bridge overview, (Photo Courtesy Arkansas DOT)

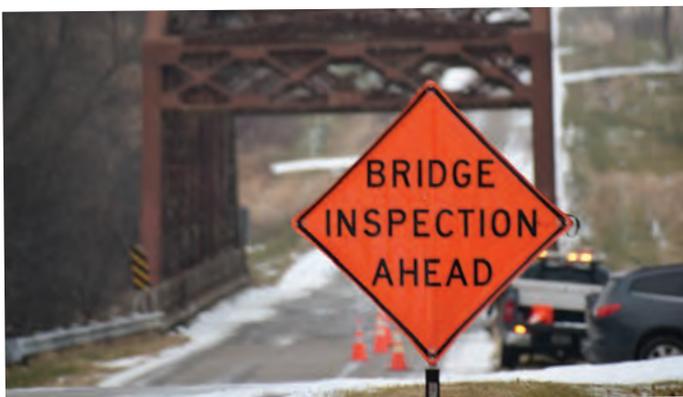
Signage improves safety. (Fickett Photo)

Traffic control has to be considered depending on what access is available and whether shoulders or lanes need to be closed. Coordination with other entities may be necessary if inspection operations impact railroads or navigable waterways.

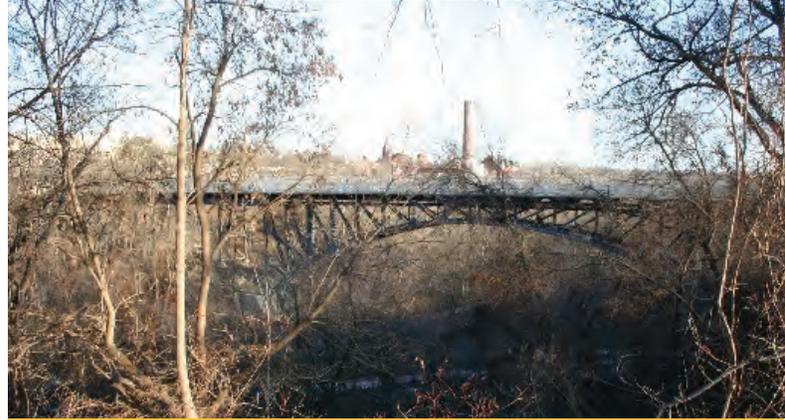
Veterans Home Bridge (Photo Courtesy MN DOT)

The Veterans Home Bridge is a historic structure erected in 1908. A bridge strengthening project brought this early 1900s landmark steel arch-truss bridge up to current load rating standards.

The project included adding steel plates to specific members of the main arch span in addition to the fracture critical, steel approach span girders. After welding was performed, inspectors discovered numerous cracks in the new welds. The cracking problems were specific to the welds made on the girder webs of the approach span girders.

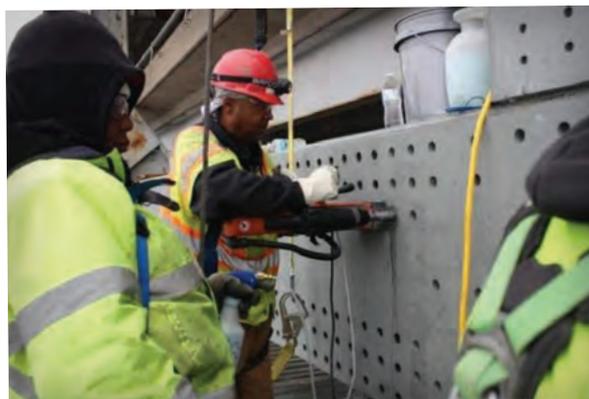
Bridge repair on the Sherman Minton Bridge (Construction Equipment Guide Photo)

The Sherman-Minton Bridge was closed for approximately five months while repairs were made to address hydrogen-induced weld cracking. The Hernando de Soto Bridge was closed for approximately 2½ months while the partially fractured tie girder and additional locations with hydrogen cracking were inspected and then repaired.
